## Thermal imaging cameras: a fast and reliable tool for testing solar panels.

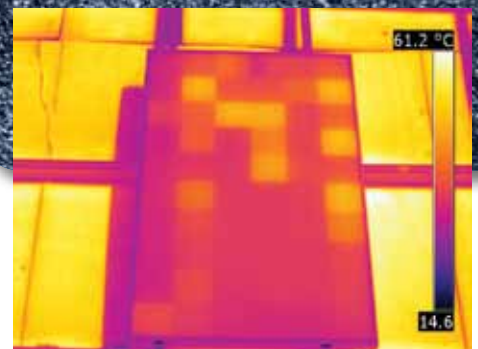
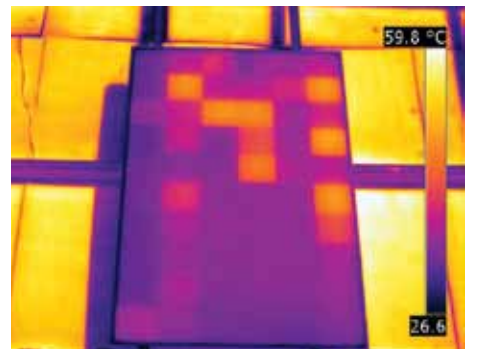
*Thermogram with level and span in automatic mode (above) and in manual mode (below).*

Handheld thermal imaging cameras for predictive maintenance inspections typically have an uncooled microbolometer detector sensitive in the 8–14  $\mu\text{m}$  waveband. However, glass is not transparent in this region. When solar cells are inspected from the front, a thermal imaging camera sees the heat distribution on the glass surface but only indirectly the heat distribution in the underlying cells. Therefore, the temperature differences that can be measured and seen on the solar panel's glass surface are small. In order for these differences to be visible, the thermal imaging camera used for these inspections needs a thermal sensitivity  $\leq 0.08\text{K}$ . To clearly visualize small temperature differences in the thermal image, the camera should also allow manual adjustment of the level and span.

Photovoltaic modules are generally mounted on highly reflective aluminum framework, which shows up as a cold area on the thermal image, because it reflects the thermal radiation emitted by the sky. In practice that means that the thermal imaging camera will record the framework temperature as being well below  $0^\circ\text{C}$ . Because the thermal imaging camera's histogram equalization automatically adapts to the maximum and minimum measured temperatures, many small thermal anomalies will not immediately be visible. To achieve a high contrast thermal image continuous manual correction of the level and span would be needed.

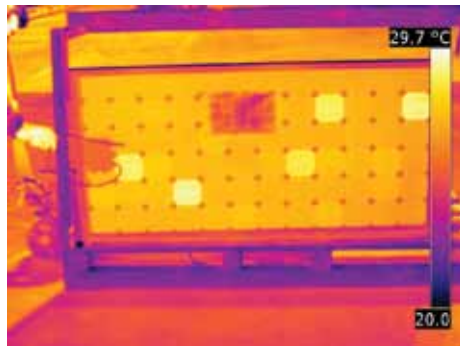
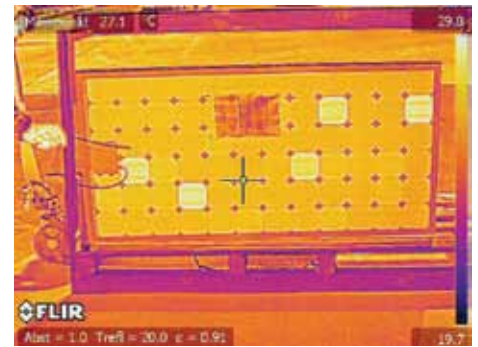
Thermal image without DDE (left) and with DDE (right).

The so-called DDE (Digital Detail Enhancement) functionality provides the solution. DDE automatically optimizes image contrast in high dynamic range scenes, and the thermal image no longer needs to be adjusted manually. A thermal imaging camera that has DDE is therefore well suited for fast and accurate solar panel inspections.

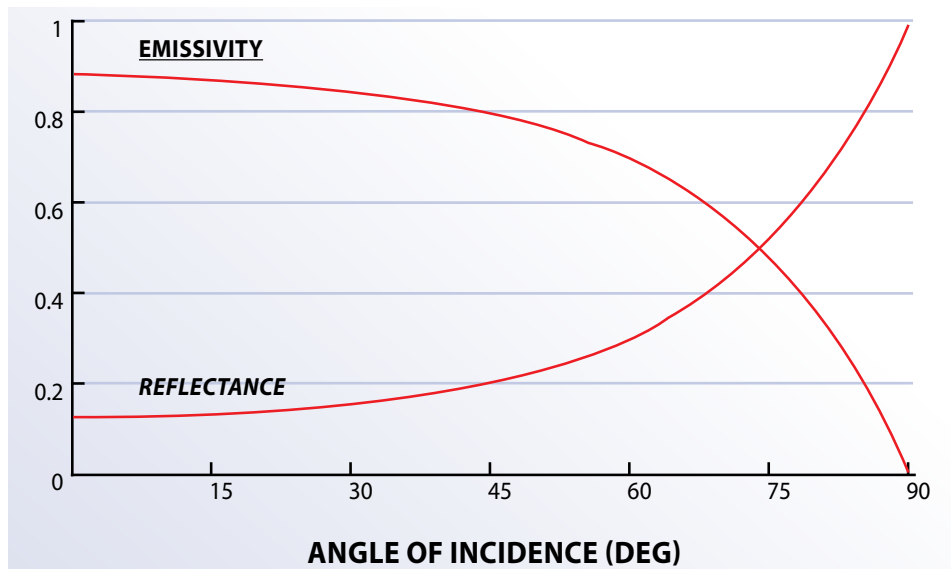
Angle dependence of the emissivity of glass

In order to avoid reflection of the thermal imaging camera and the operator in the glass, it should not be positioned perpendicularly to the module being inspected. However, emissivity is at its highest when the camera is perpendicular, and decreases with an increasing angle. A viewing angle of 5–60° is a good compromise (where 0° is perpendicular).

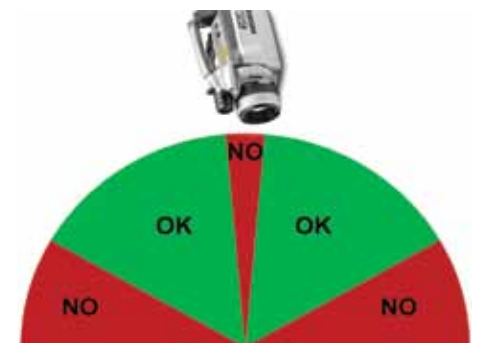
Viewing angle recommended (green) and to be avoided (red) during thermographic inspections.

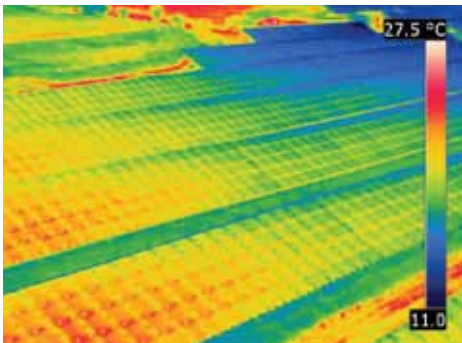
In order not to draw false conclusions you need to hold the thermal imaging camera under a correct angle when inspecting solar panels.

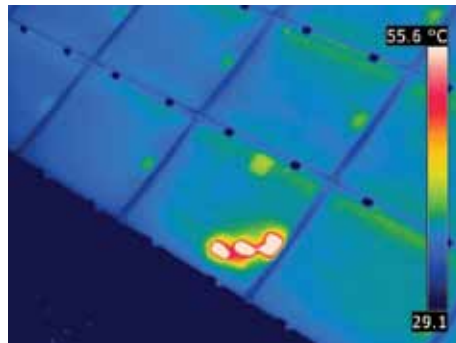
Thermal image made using a FLIR P660 camera on a flight over a solar farm. (Thermogram courtesy of Evi Müllers, IMM)

The camera should also have an interchangeable lens, so the operator can switch to a telephoto lens for long distance observations, such as from a helicopter. It is advisable, however, to only use telephoto lenses with thermal imaging cameras that have a high image resolution. Low resolution thermal imaging cameras will be unable to pick up the small thermal details

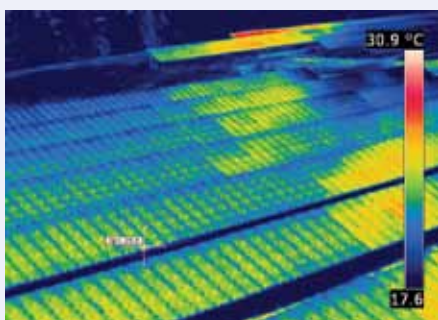
This thermal image shows large areas with elevated temperatures. Without more information, it is not obvious whether these are thermal anomalies or shadowing/reflections.

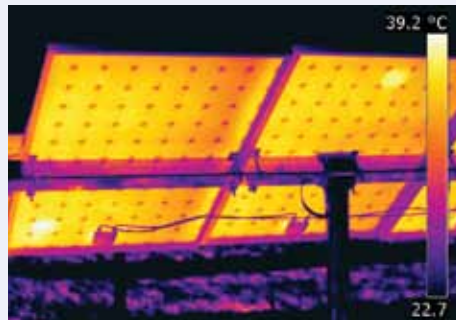
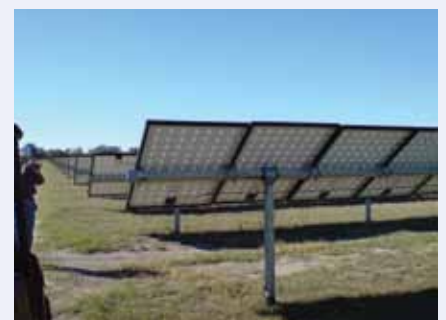
Thermal image of the back of a solar module taken with a FLIR P660 camera. Its corresponding visual image is shown on the right.

In most cases installed photovoltaic modules can also be inspected with a thermal imaging camera from the rear of a module. This method minimizes interfering reflections from the sun and the clouds. In addition, the temperatures obtained at the back may be higher, as the cell is being measured directly and not through the glass surface.

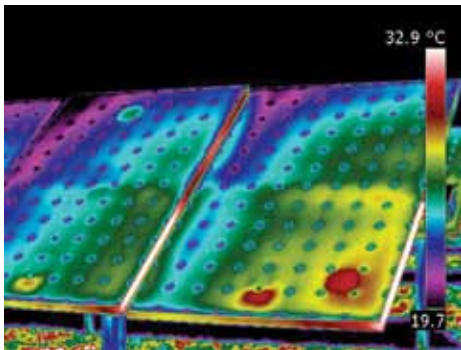
These red spots indicate modules that are consistently hotter than the rest, indicating faulty connections.

and areas can indicate several different faults. If an entire module is warmer than usual that might indicate interconnection problems. If individual cells or strings of cells are showing up as a hot spot or a

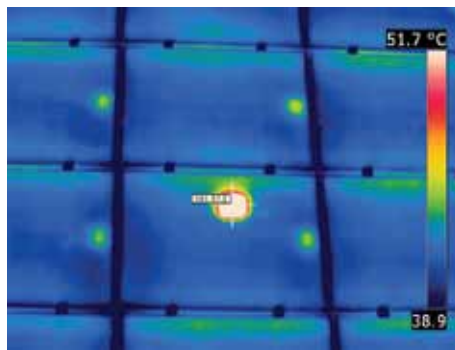
This hot spot within one solar cell indicates physical damage within the cell.

Shadowing and cracks in cells show up as hot spots or polygonal patches in the thermal image. The temperature rise of a cell or of part of a cell indicates a defective cell or shadowing. Thermal images obtained under load, no-load, and short-circuit conditions should be compared. A comparison of thermal images of the front and rear faces of the module can also give valuable information. Of course, for correct identification of the failure, modules showing anomalies must also be tested electrically and inspected visually.

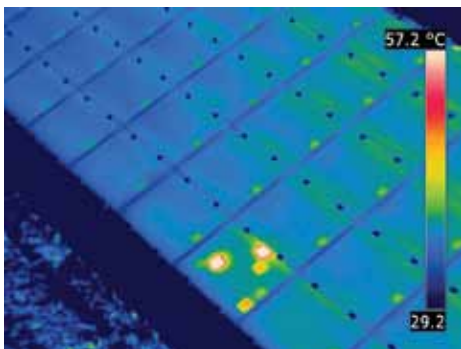
This thermal image shows an example of the so-called 'patchwork pattern', which indicates that this panel has a defective bypass diode.

warmer 'patchwork pattern', the cause can usually be found either in defective bypass diodes, in internal short-circuits, or in a cell mismatch.
